Tin Whisker Observations
on Tin-Coated Copper Bus Bar
Obtained from
“A Large Paper Mill in Sweden”

Jay Brusse/Dell Perot Systems at
NASA Goddard Space Flight Center
December 2009
Jay.A.Brusse@nasa.gov

Images from 2009 Arcing Event @ Paper Mill in Sweden

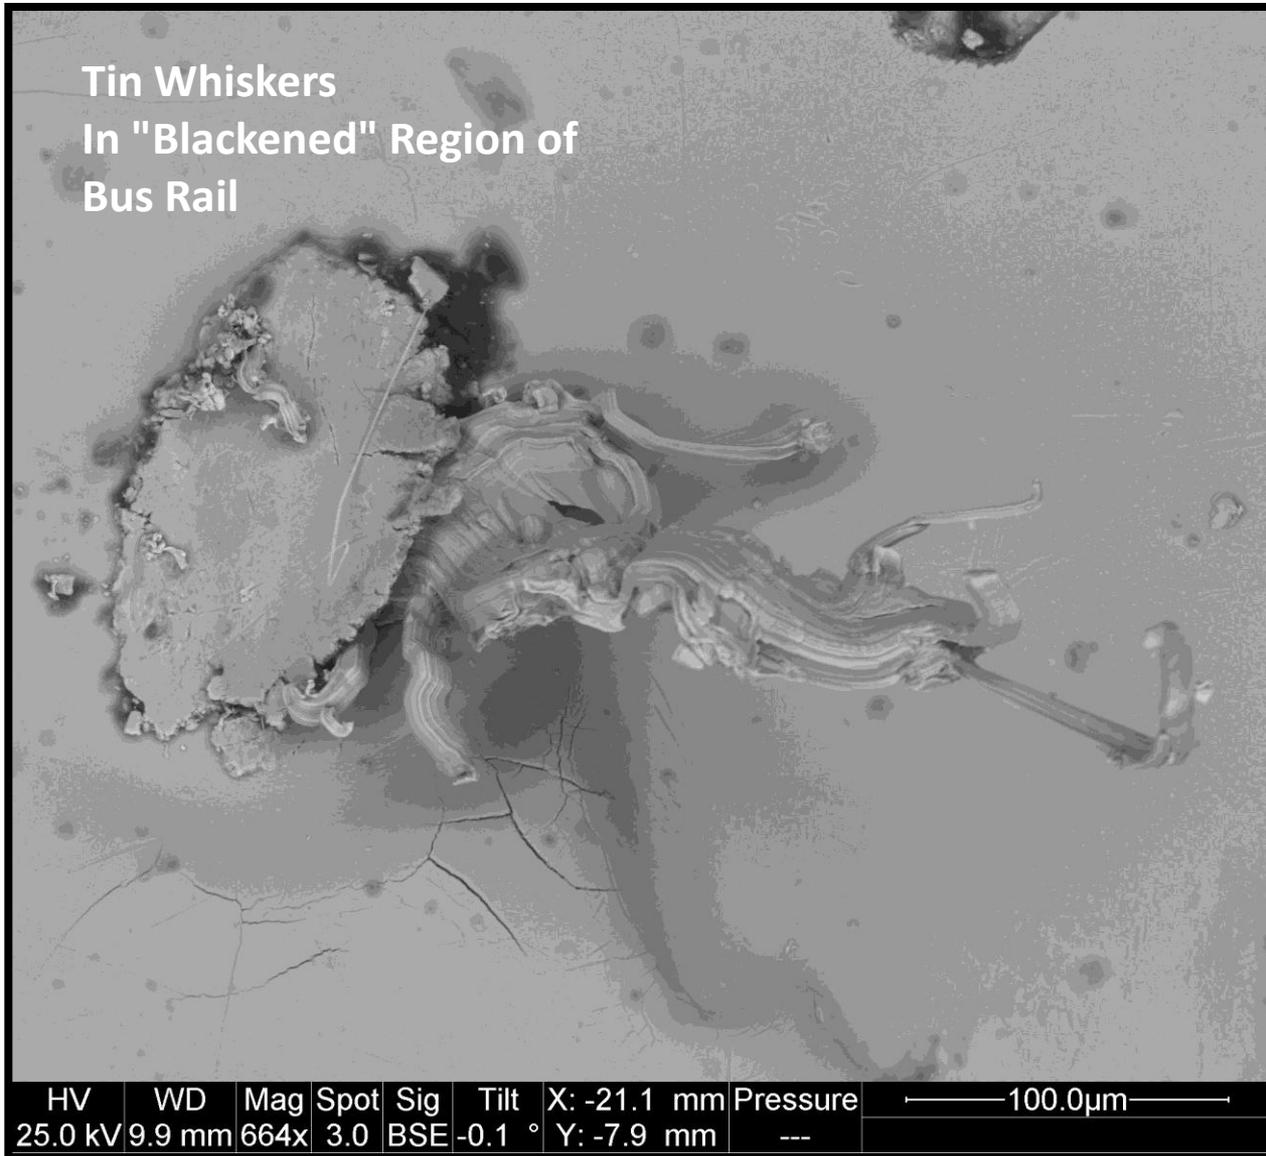
Tin Whiskers
In "Blackened" Region of
Bus Rail

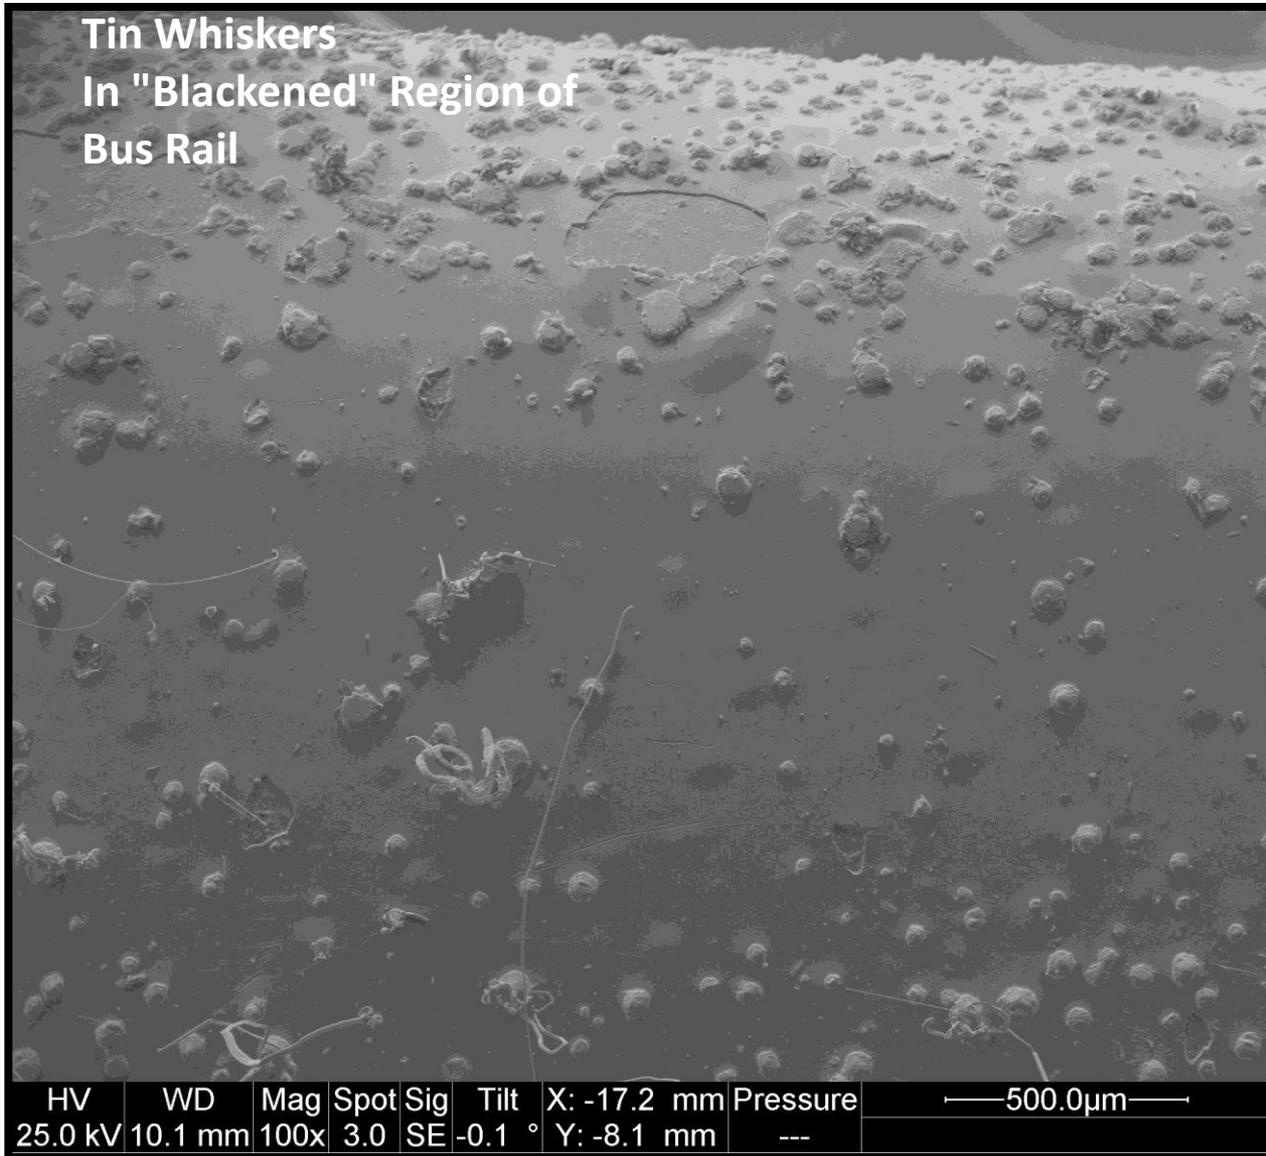
**Tin Whiskers
In "Blackened" Region of
Bus Rail**

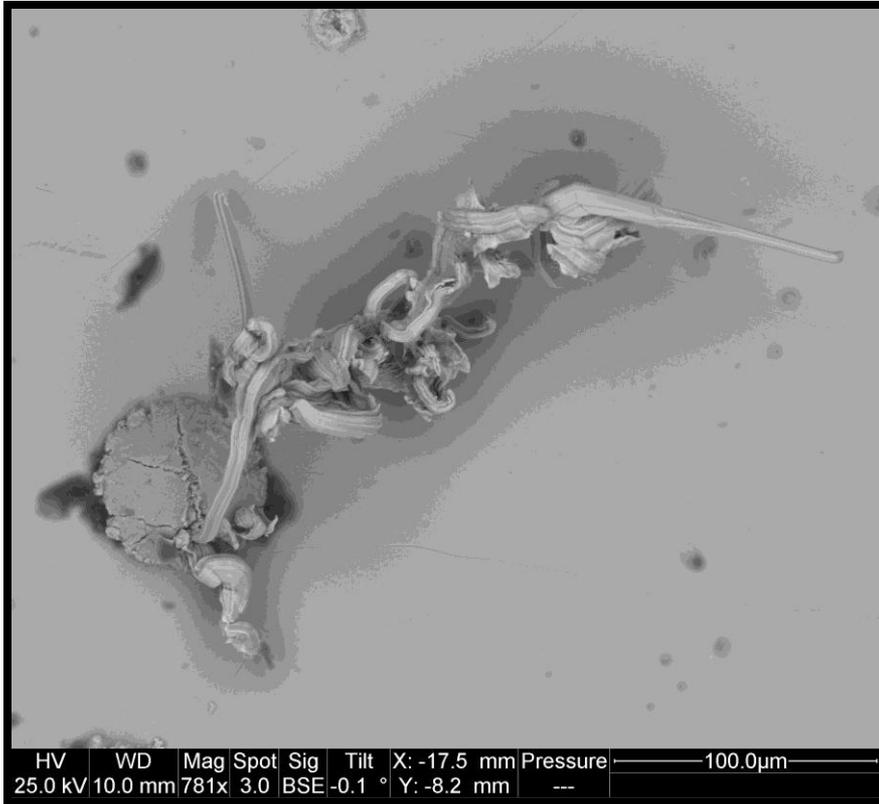
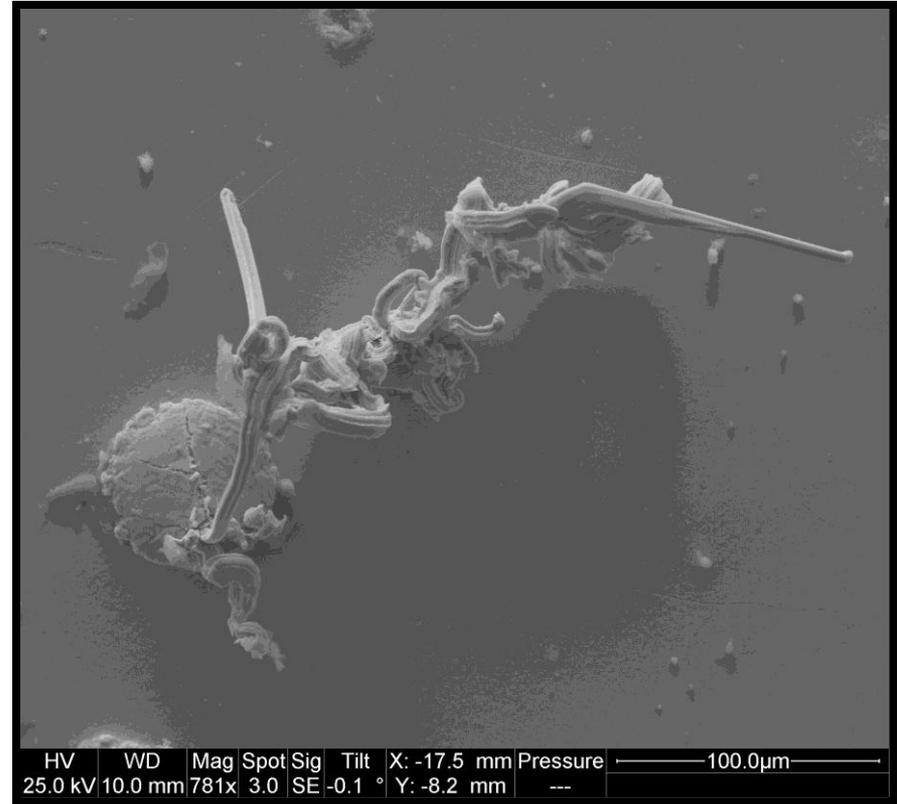
Tin Whiskers

BSE view – difference in materials

SE view – topographical image

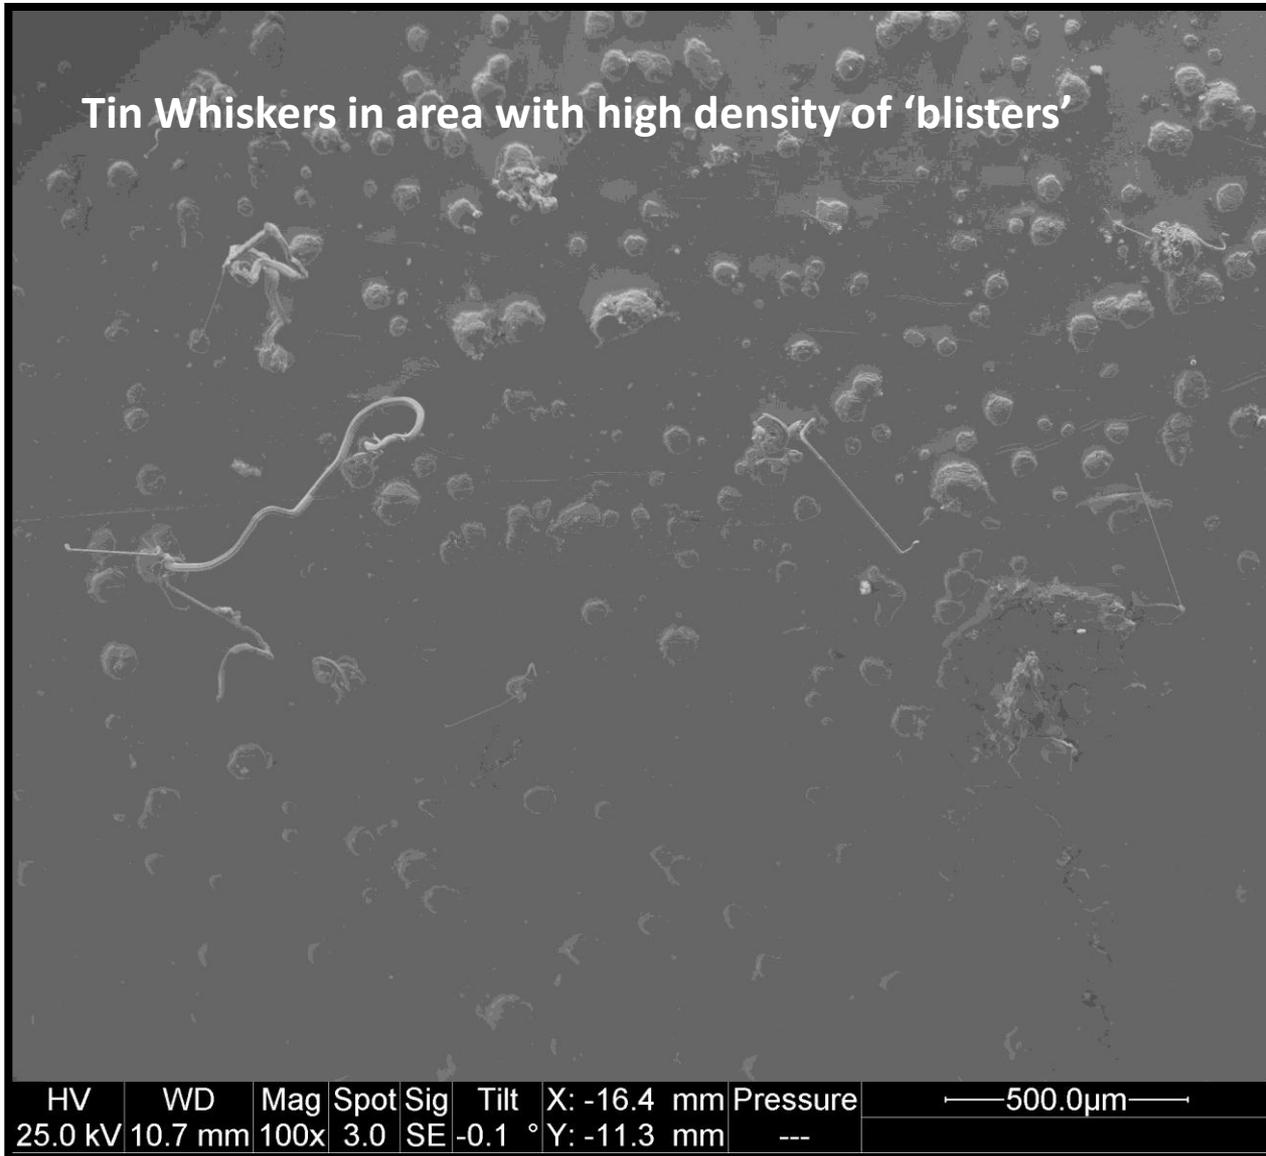
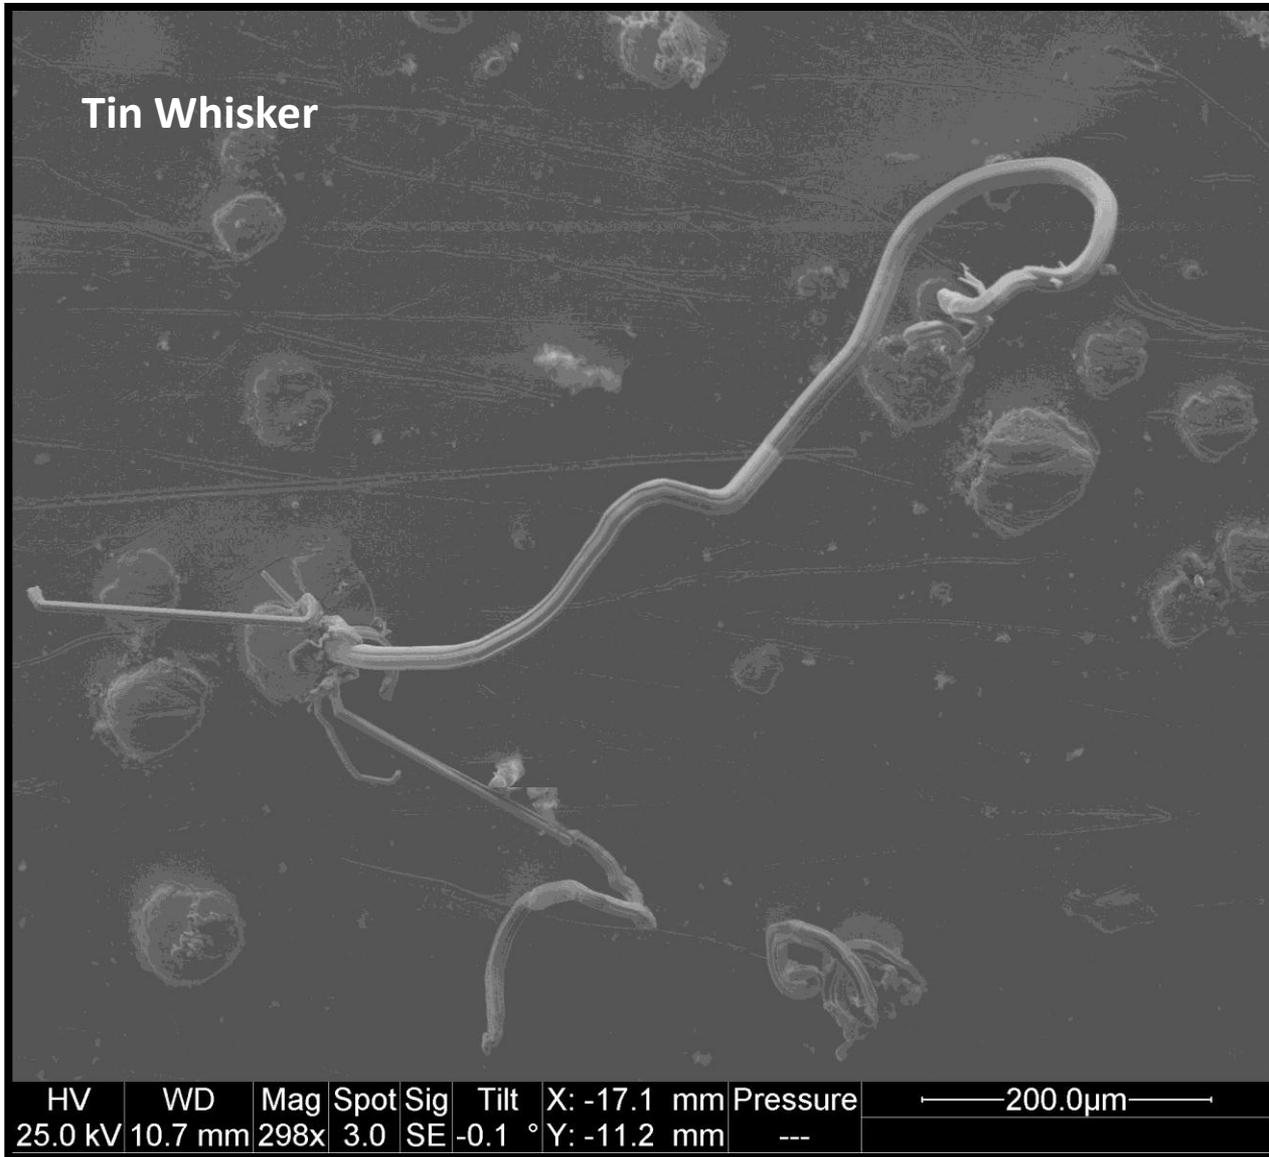
Tin Whiskers in area with high density of 'blisters'

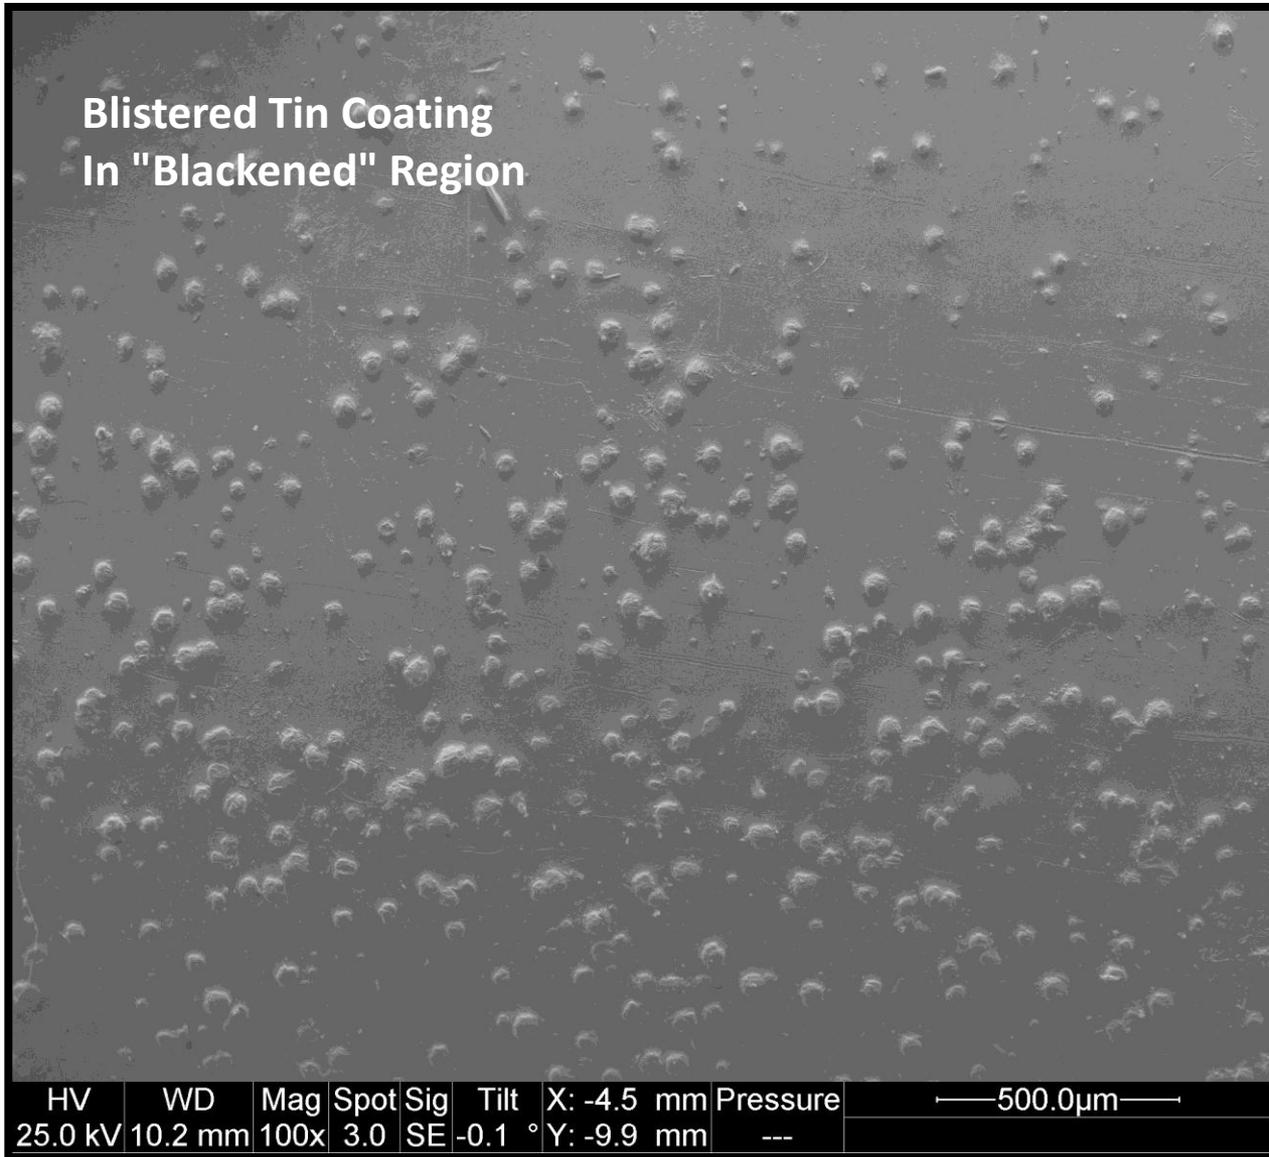
**Blistered Tin Coating
In "Blackened" Region**

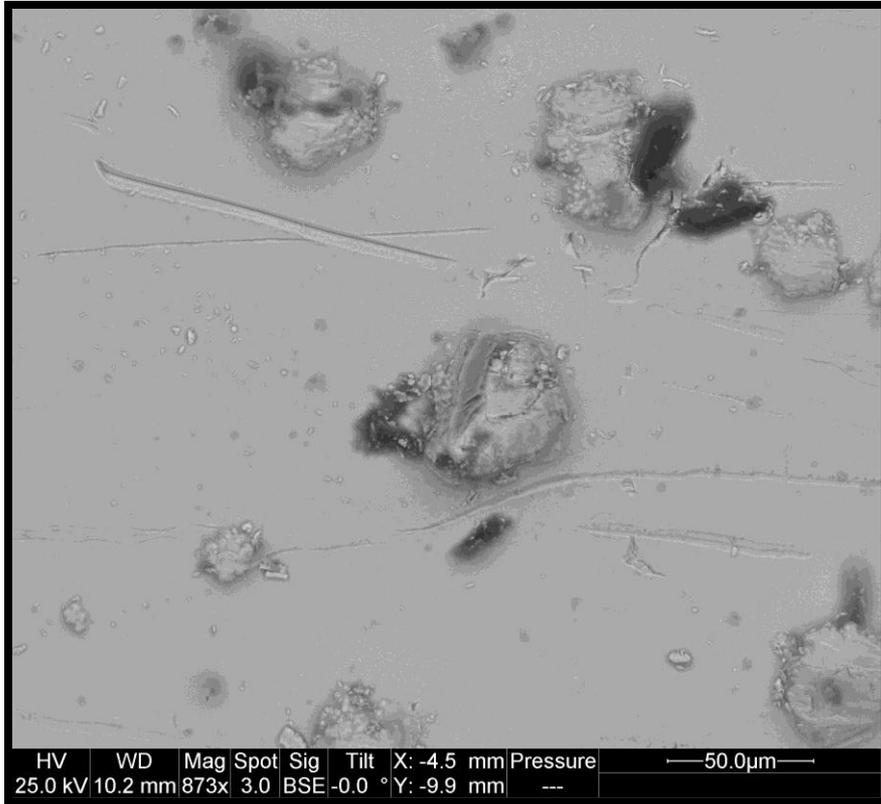
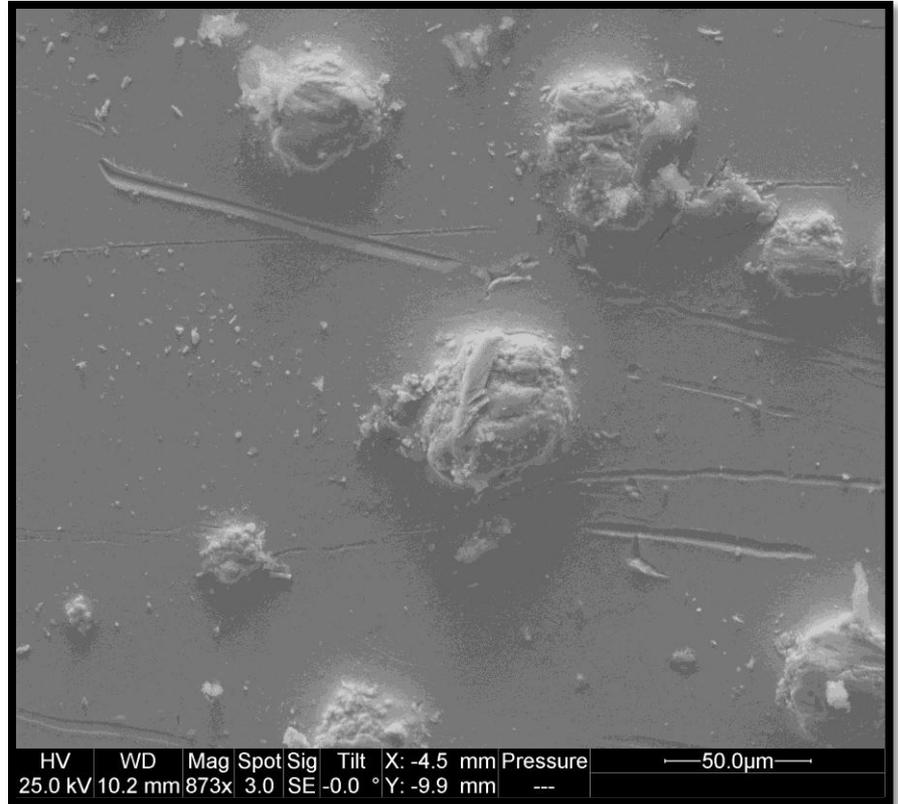
Blistered Tin Coating In "Blackened" Region

BSE view – difference in materials

SE view – topographical image

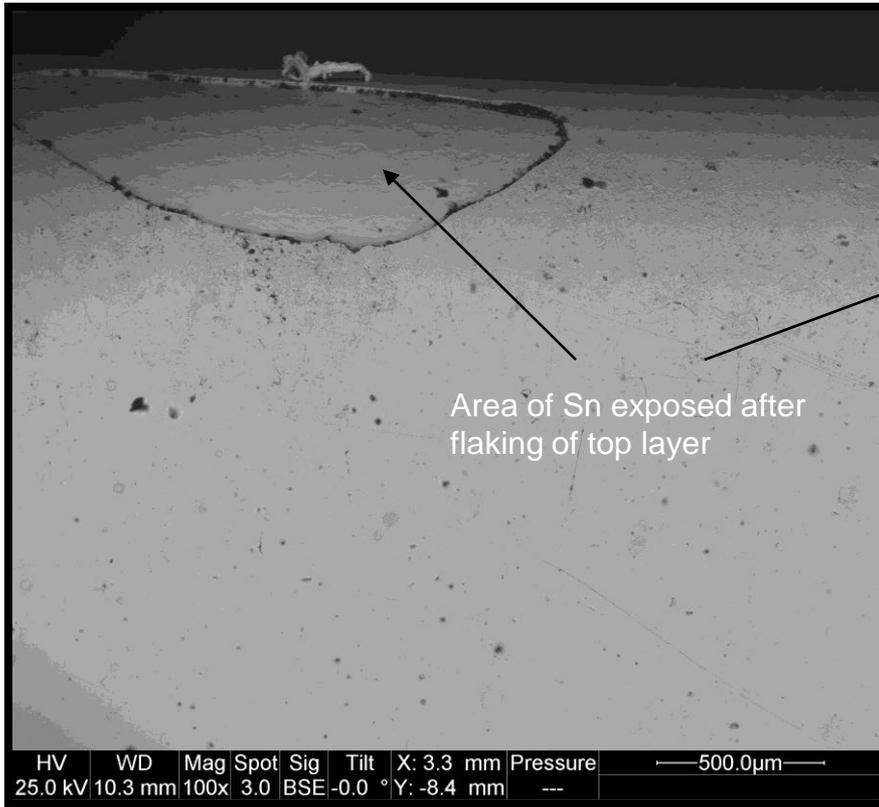
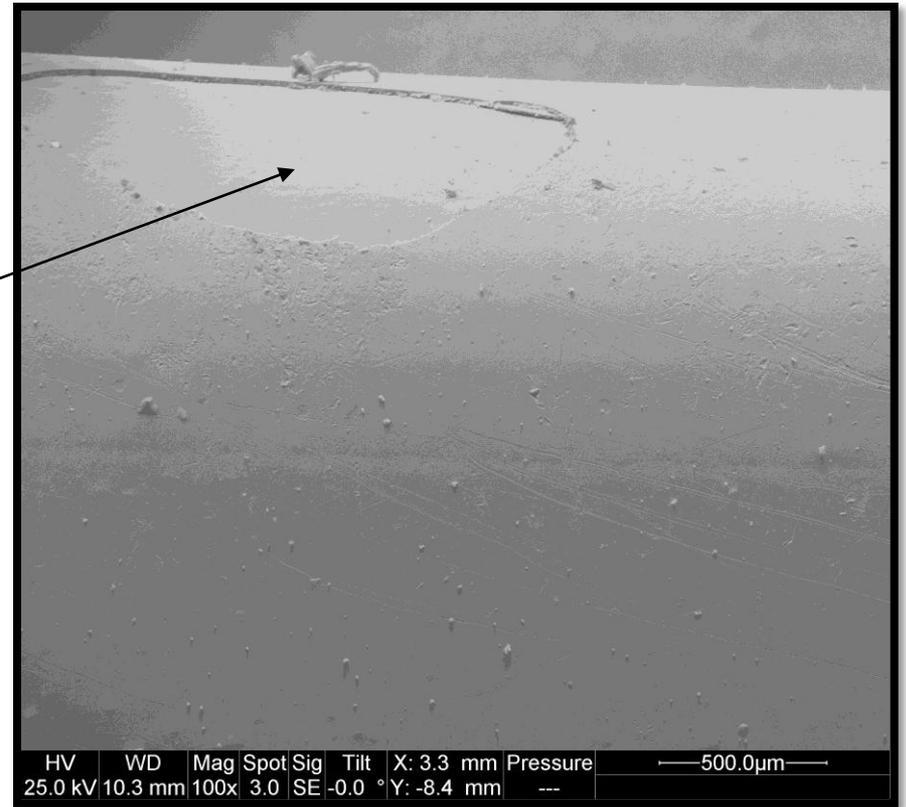
Area with a piece of top tin coating flaked-off, and more tin exposed underneath

BSE view – difference in materials

SE view – topographical image

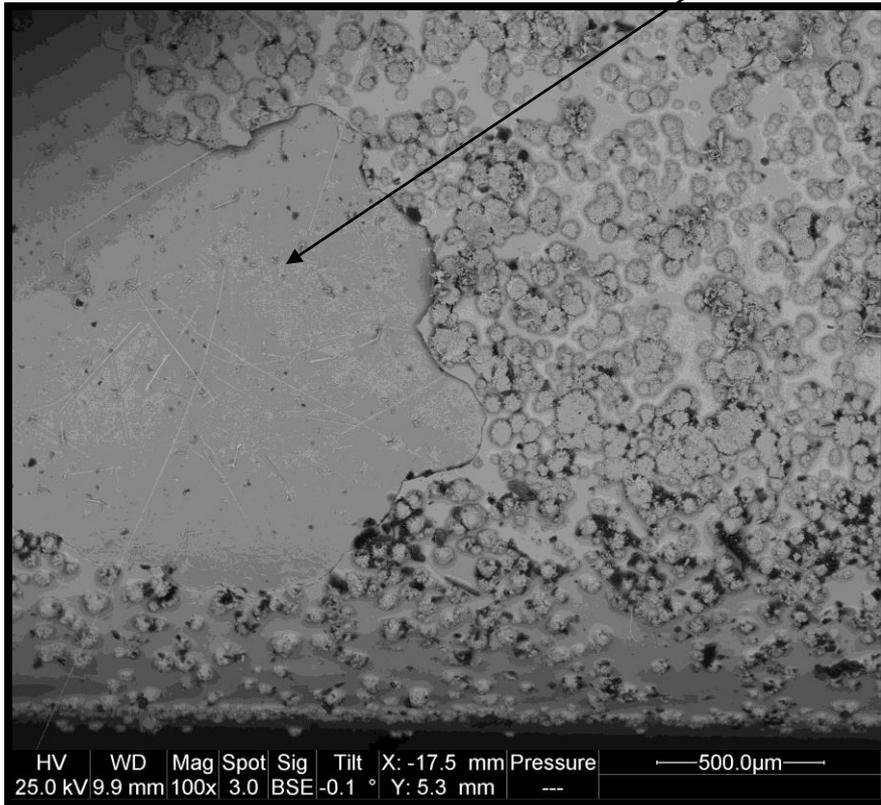
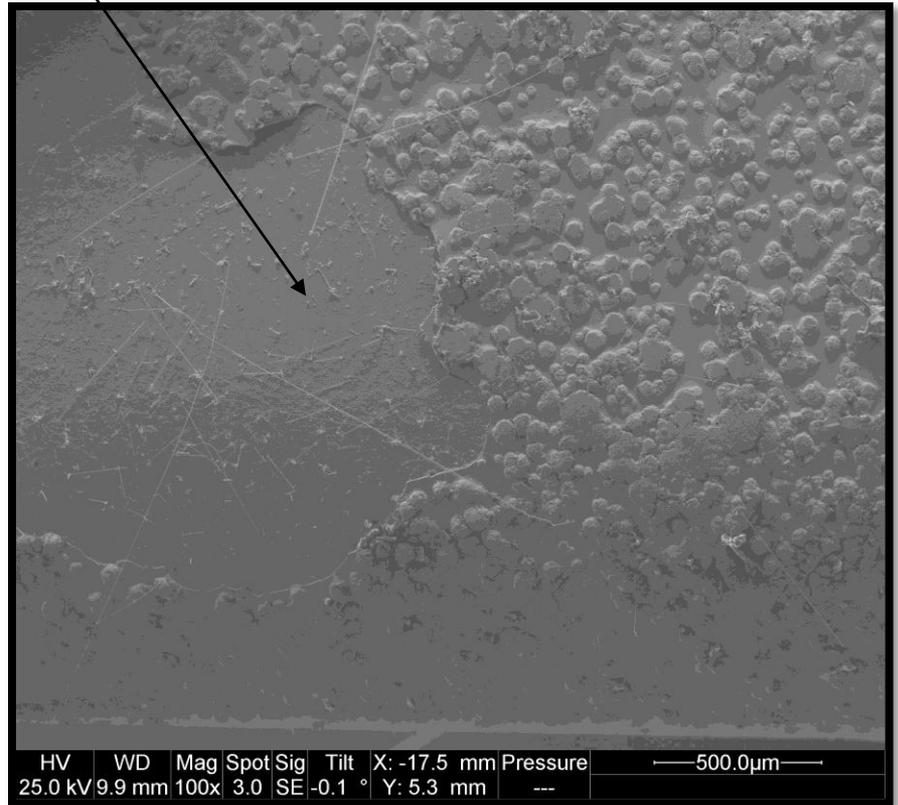
Tin Whiskers In "Blackened" Region of Bus Rail where Material has Flaked Off

Area of Sn exposed after flaking of top layer

BSE view – difference in materials

SE view – topographical image

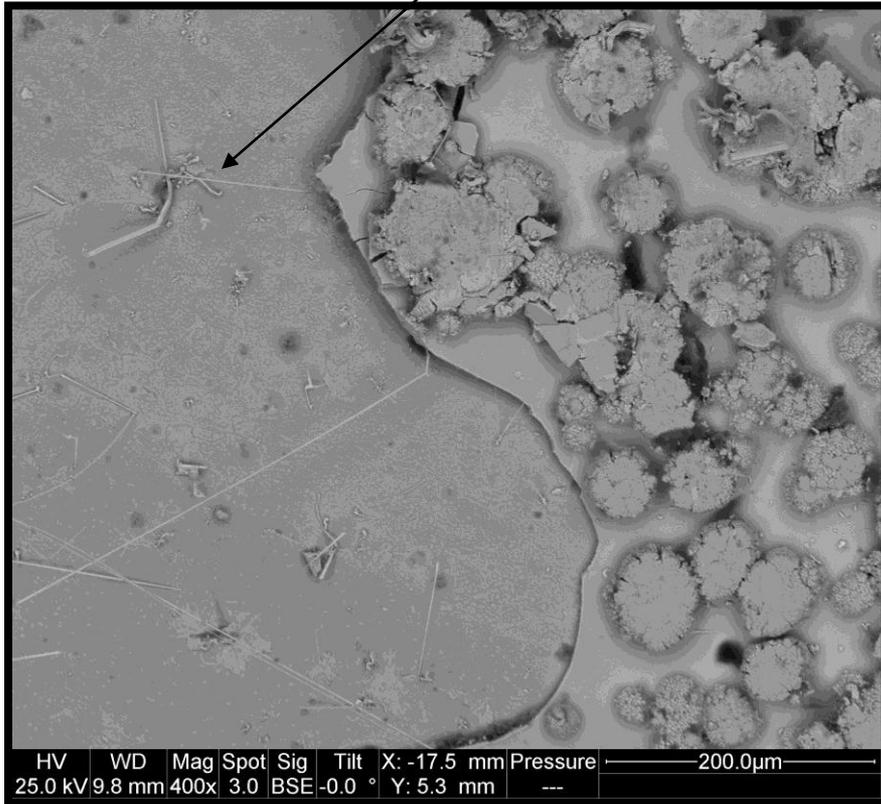
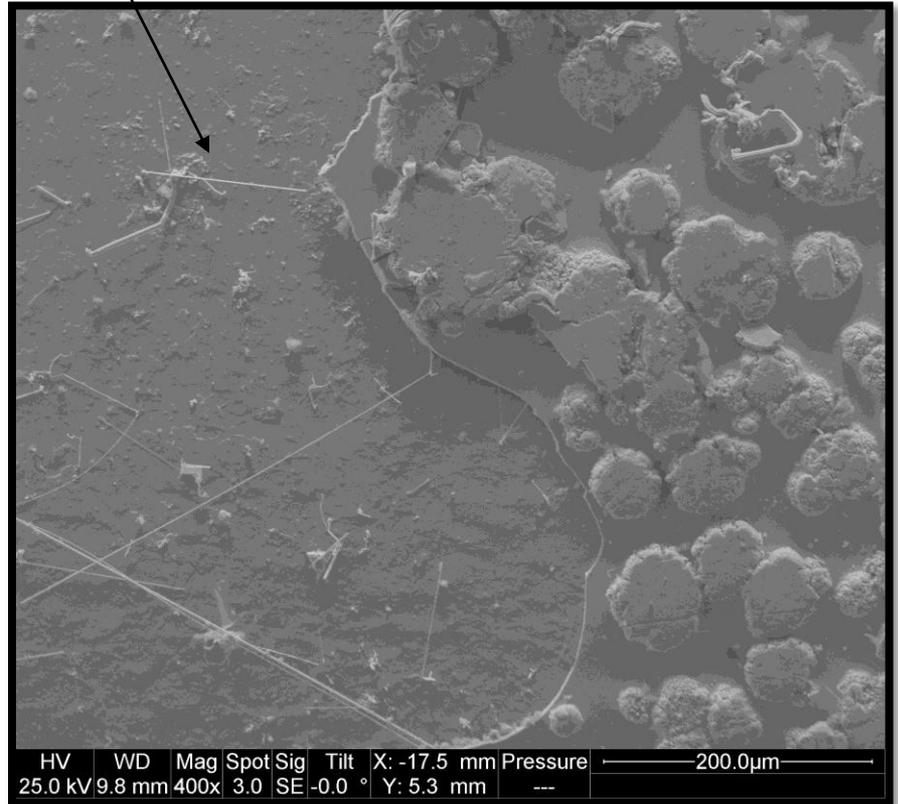
Tin Whiskers In "Blackened" Region of Bus Rail where Material has Flaked Off

Area of Sn exposed after flaking of top layer

BSE view – difference in materials

SE view – topographical image

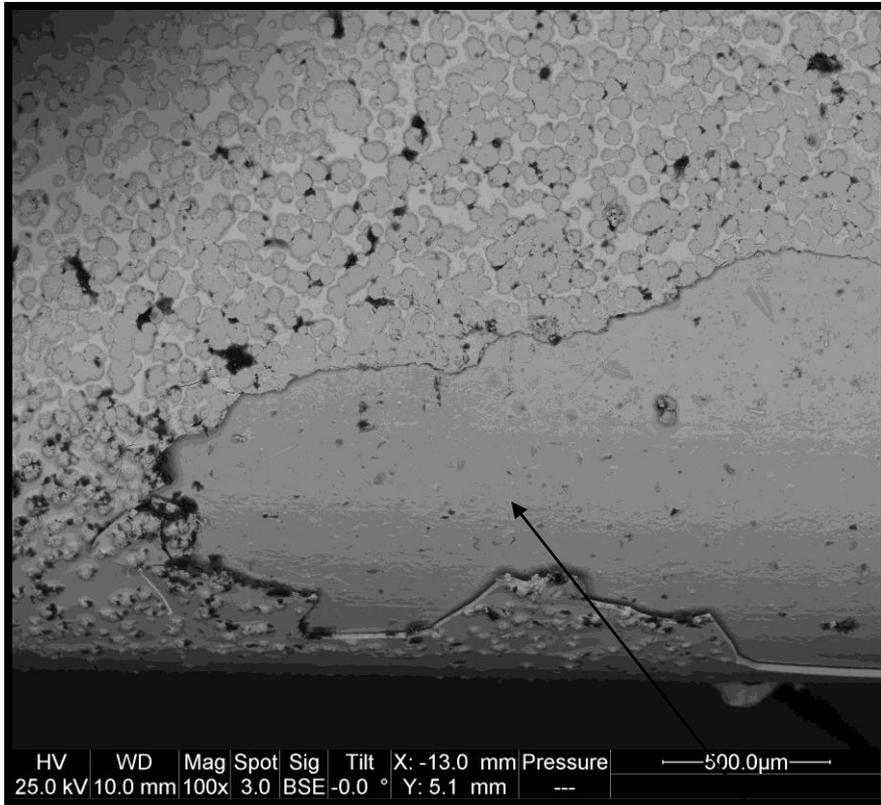
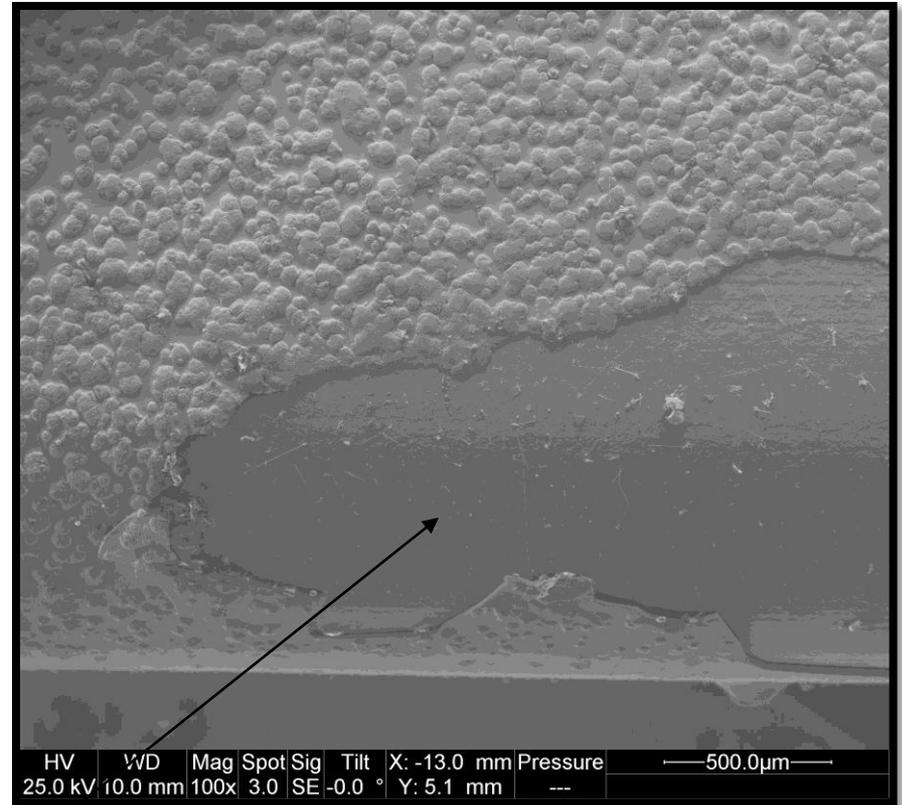
"Blackened" Region of Bus Rail where Material has Flaked Off

Area of Sn exposed after flaking of top layer

BSE view – difference in materials

SE view – topographical image

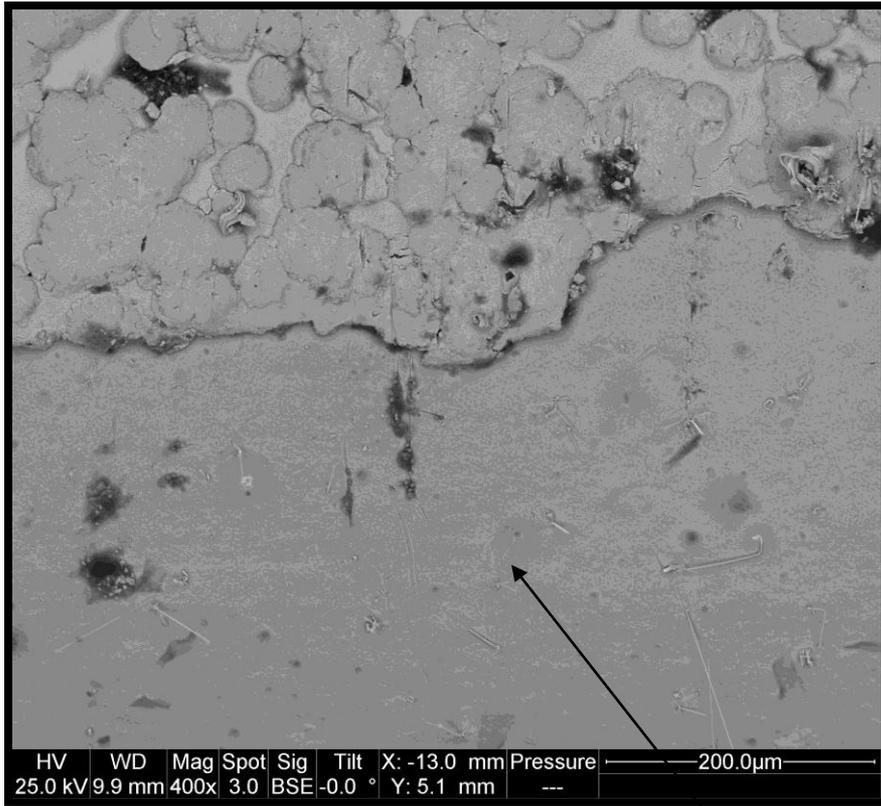
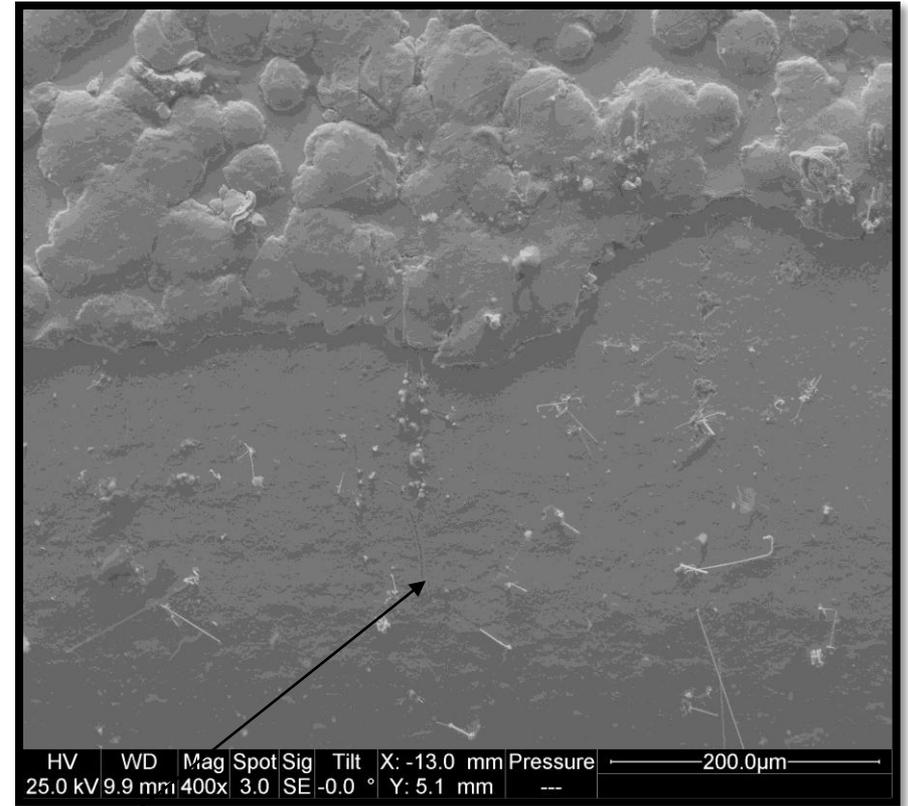
"Blackened" Region of Bus Rail where Material has Flaked Off

Area of Sn exposed after flaking of top layer

BSE view – difference in materials

SE view – topographical image
